# Unlocking the Drive

## *Exploiting Tesla Model 3*

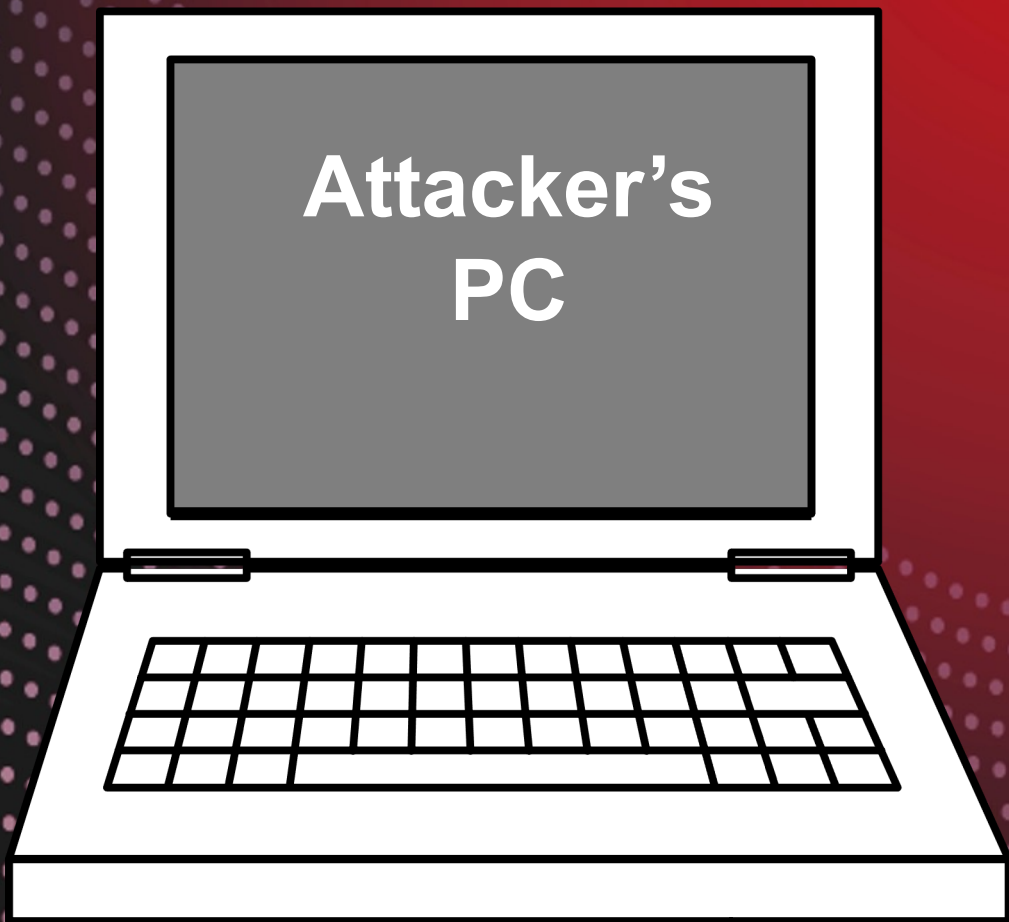
# Exploit chain

Chaining **three exploits** for a remote-to-CAN fullchain

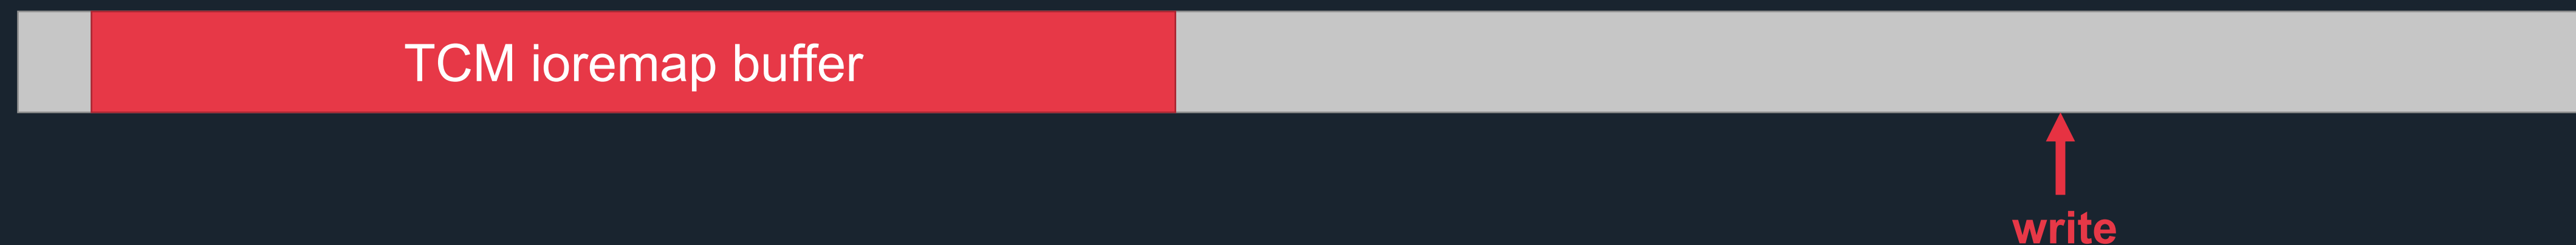
# LPE

Out-of-bound write in bcmdhd

- `d2h_r_idx_ptr` is used as an offset to write inside a ioremap region (TCM)
- The offset is not checked to be in the TCM region!
- ioremap places addresses in the vmalloc region
- **Stage2** can write out of bound after the ioremap TCM region by setting `d2h_r_idx_ptr` to a value bigger than the TCM size
- Need to find something to write on!

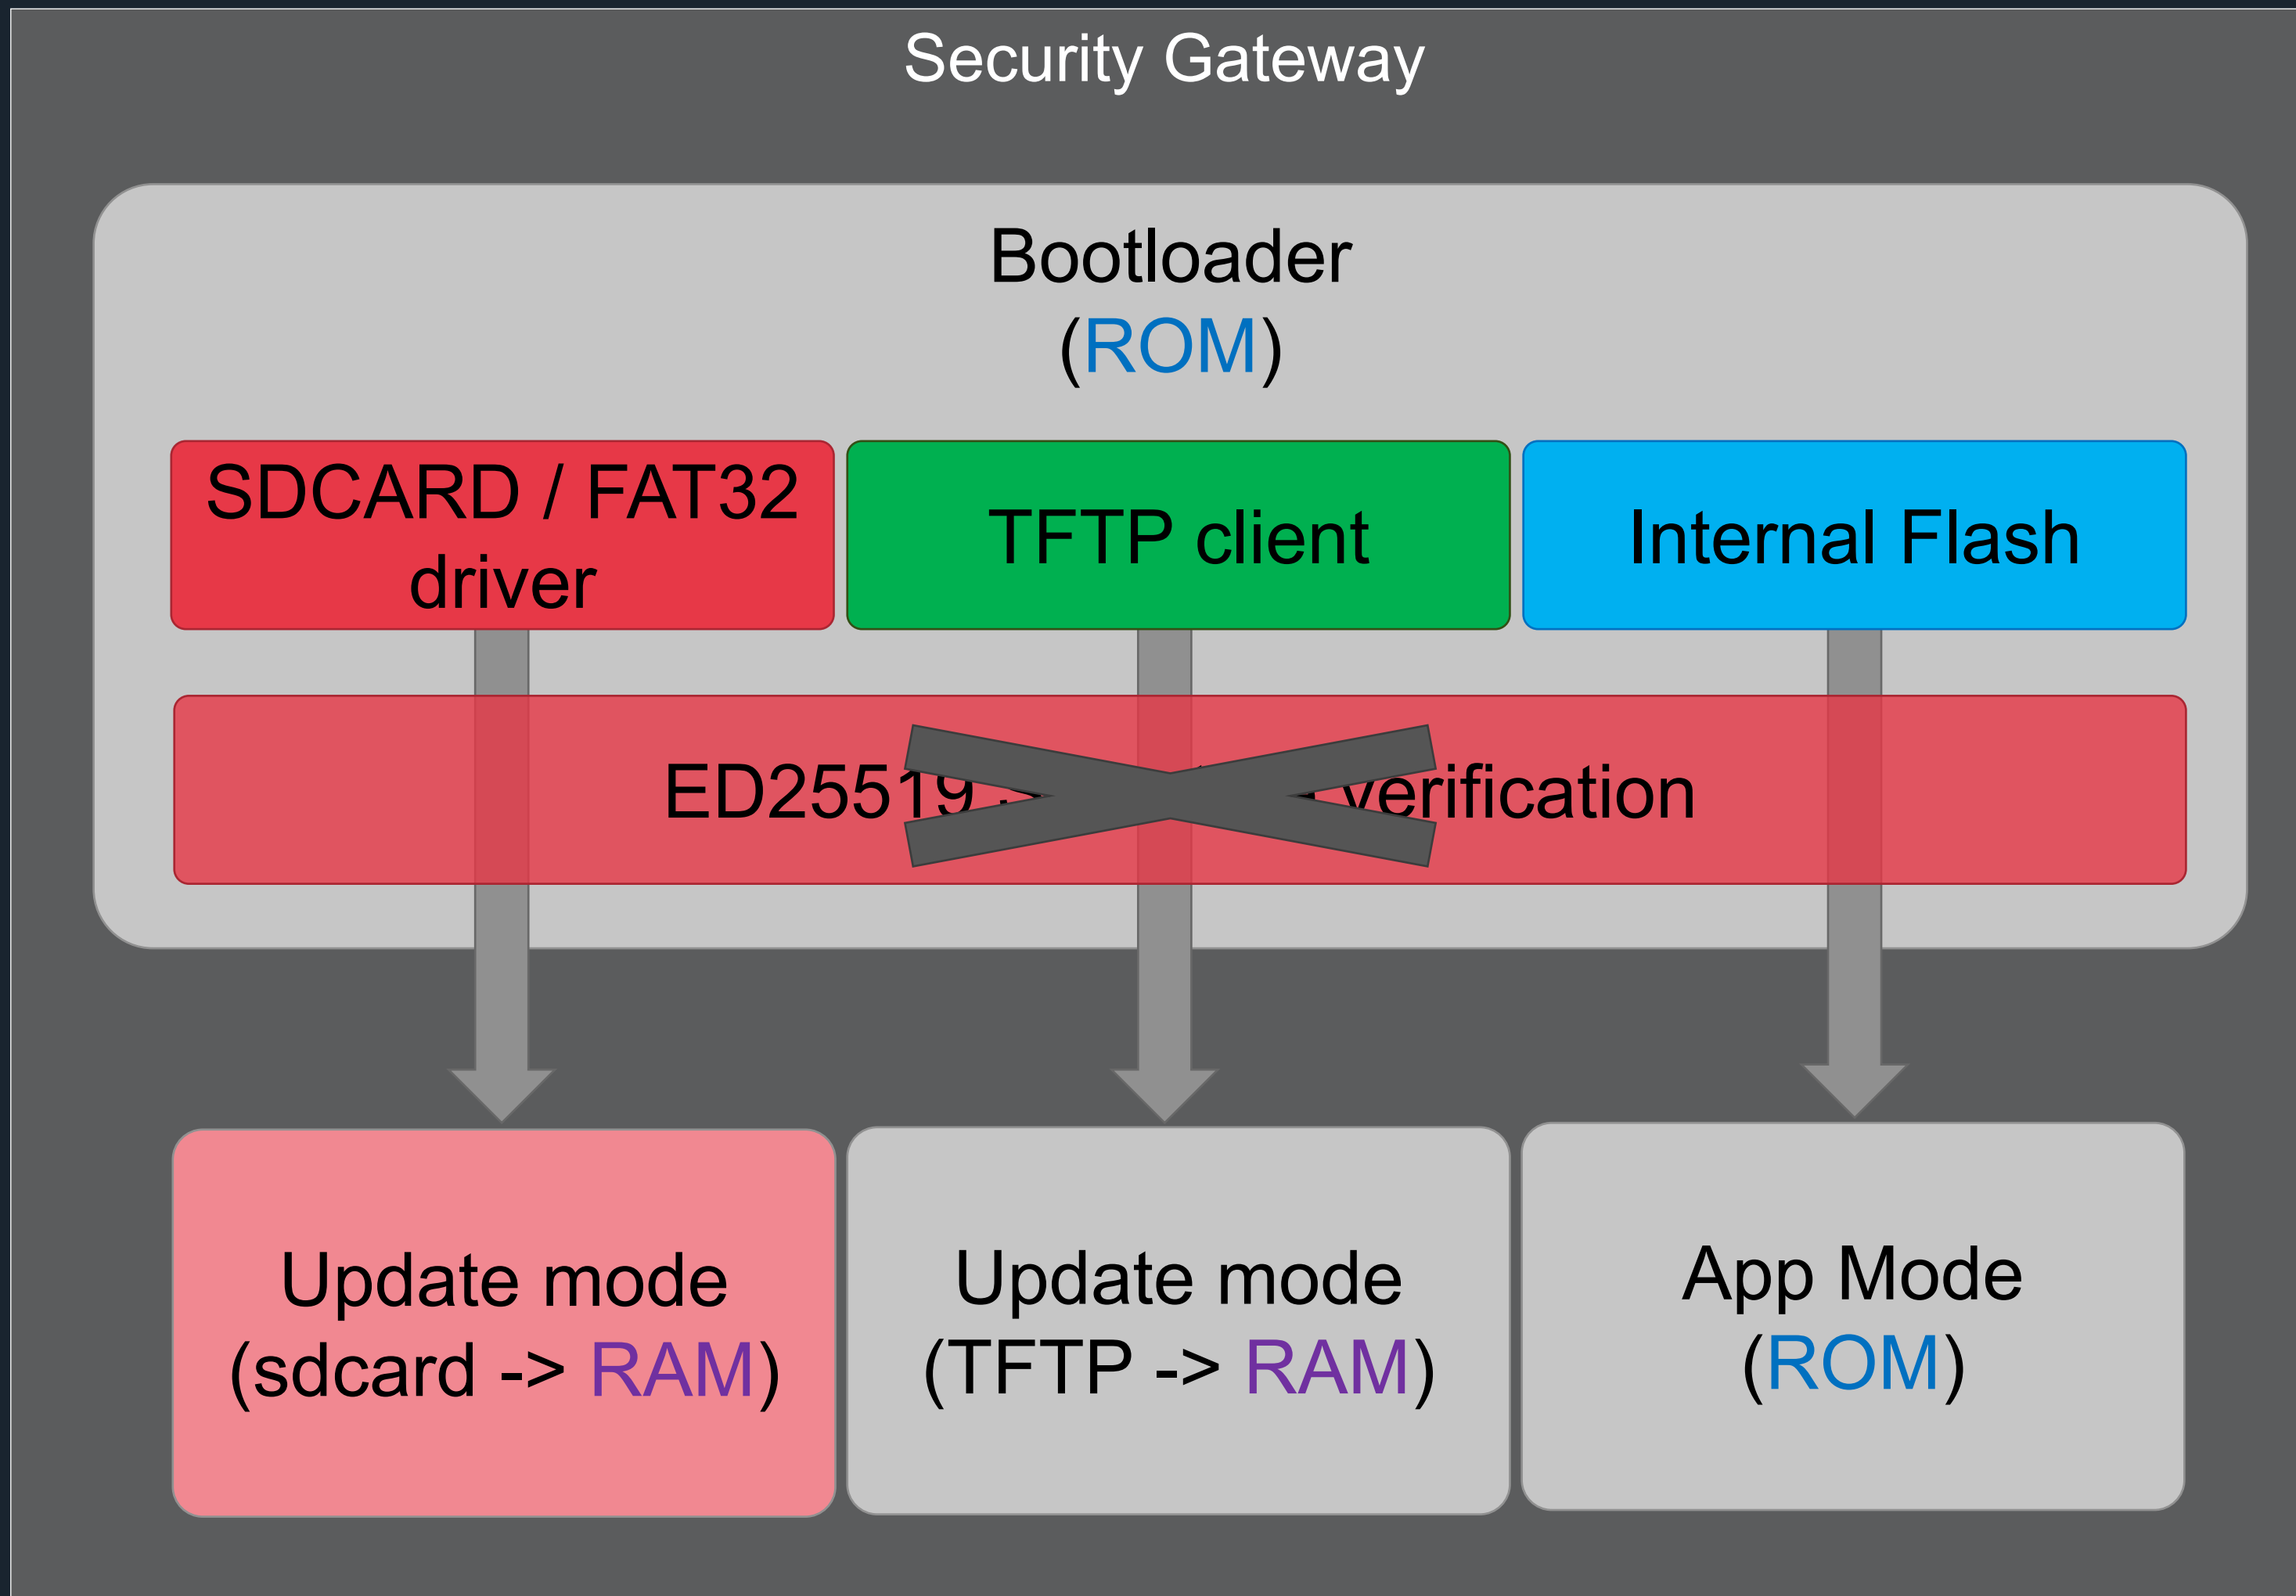
- Bootloader verifies next stages
- Hardware (NXP chip) **doesn't provide secure boot**, bootloader in the internal flash is never verified
- Gateway update mode allows to update its own firmware, including the bootloader
- Signature bypass in update mode => **code exec in bootloader**

- Bootloader patch
- Remove ED25519 signature check
- Use Update mode boot mechanism to boot on a controlled firmware
- Controlled firmware has **unrestricted access to the CAN vehicle & chassis buses**
